Pavement-renovation with Bitufor on airports

References and informations

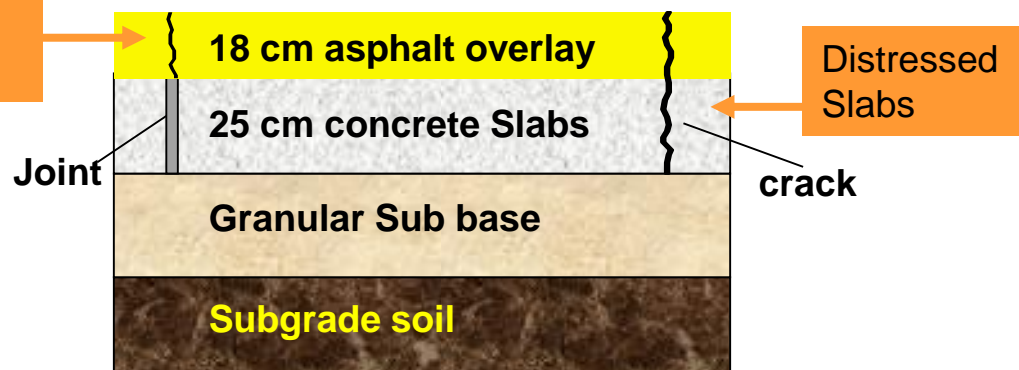
Reflective
Cracking

Situation before
renovation

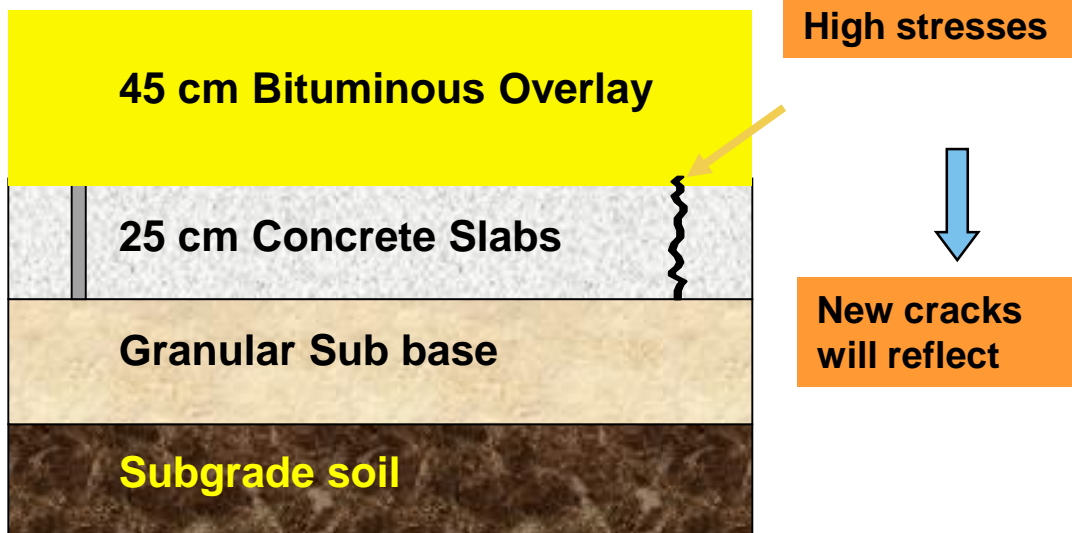
Traditional solution

Milling total depth of asphalt layer

Stabilizing concrete slabs (by crack & seat)

New bituminous overlay of 45 cm

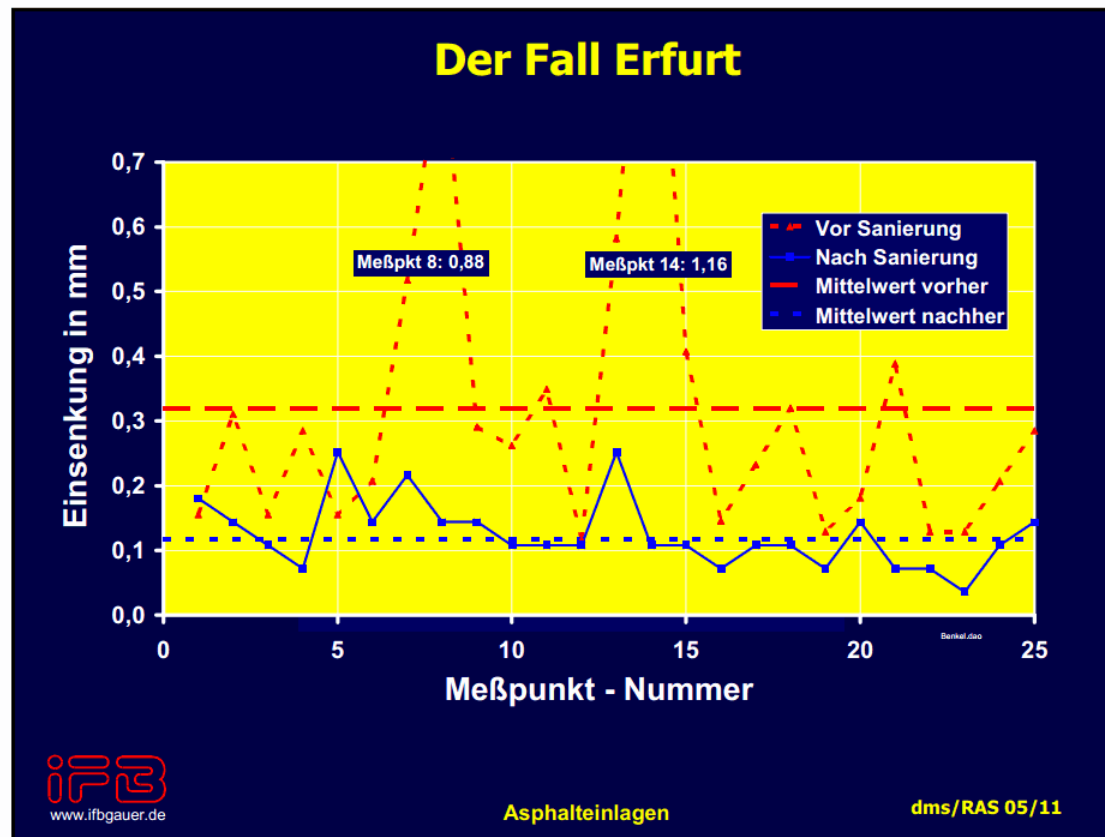
Deflection measurements of the Runway Erfurt

Deflection Measurements with the Benkelman-Beam before and after rehabilitation

- Bitufor shows higher Bearing Capacity compared to traditional solution
- 10 cm less to mill
- no ‘crack & seat’ operation
- 45% savings in asphalt
- reinforced against reflective cracking
- 40% shorter execution time (weekend = 17.500 m²)

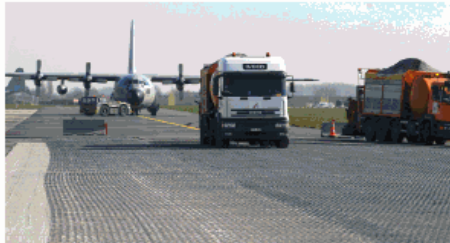
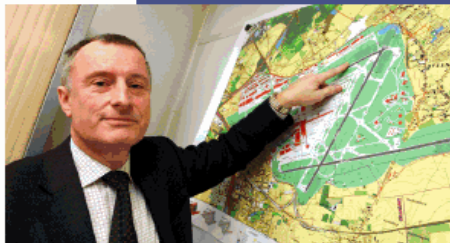
Maintenance of taxiways at Brussels International

Location	The Brussels Airport Company
Size of the project	7 taxiways
Prescriber	-
Contractor	NV Mobilmat
Date of execution	2000 - 2008

The concrete taxiways were in a terrible state. The concrete slabs were starting to show horizontal and vertical cracks and in the joints the concrete started to crumble. At the time, however, the budget did not allow for any of the full renovations of this surfacing.

Air traffic at the airport cannot be compared to daily traffic on the roads. Aeroplanes are responsible for huge wear and tear affecting the pavement surface. Consequently, the airport had to start looking for very solid and durable reinforcement. Mesh Track was the only alternative for them to solve the problem.

At the moment, 7 different taxiways have been renovated with Mesh Track. In an 8-year period, they have had only positive experiences with this durable solution.

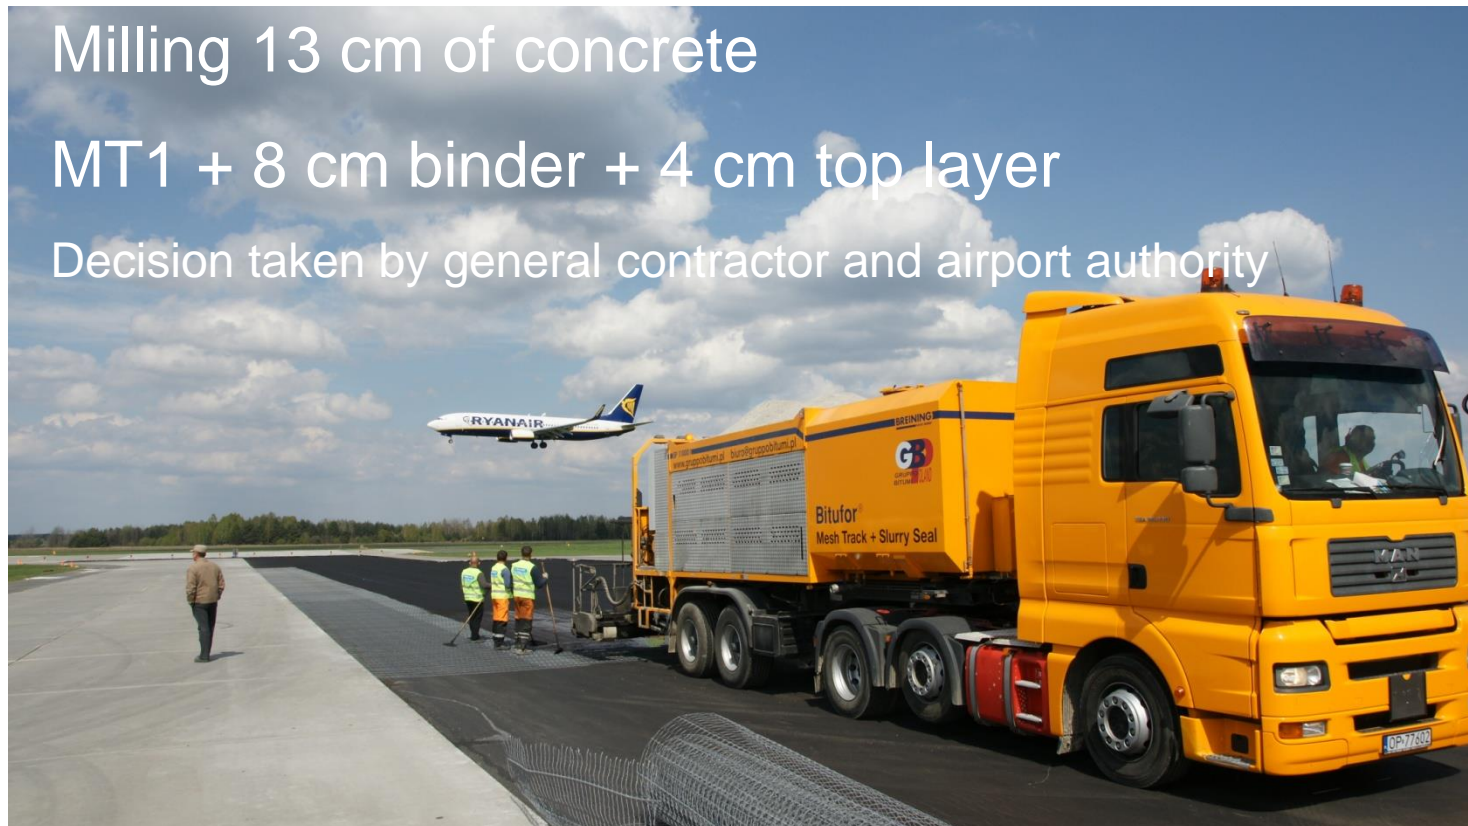
Milling 13 cm of concrete

MT1 + 8 cm binder + 4 cm top layer
